# BELZONA SOLUTION FOR SPALLED VICTORIAN LINTEL

ID: 4752

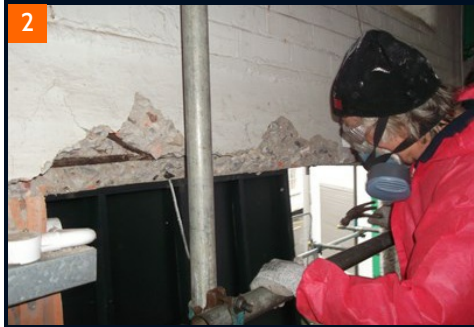
The lintels of the main door and windows had suffered severe deterioration. Carbonation of the concrete had allowed rebar corrosion leading to spalling of the concrete. The Belzona solution was selected due to the materials lightweight, non-porous and high adhesion together with its ability to complete the repair quickly and with minimal disturbance.

1. View of the main lintel at initial inspection
2. Preparation of the main lintel
3. Application being carried out to the adjacent window lintel showing the corner of the main lintel with the application completed
4. Close up of the completed application on the main lintel
