# BELZONA PROTECTS FLOATING TANK ROOF

ID: 4753

Storage tank farm at a petrochemical refinery situated close to the coastline.

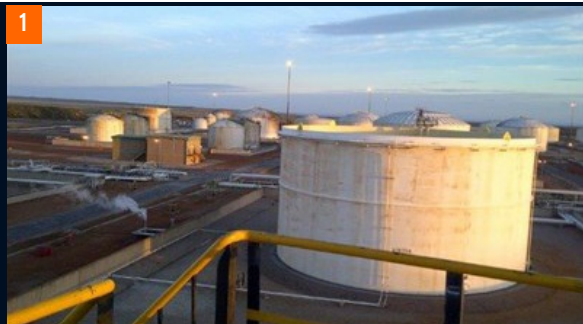
1. Tank farm with tank to be coated in the foreground
2. First coat of Belzona 6111 being applied
3. First coat of Belzona 5111 being applied
4. Finished floating tank roof
