# BELZONA REBUILDS AND PROTECTS SEAWATER STRAINER

ID: 4783

Seawater strainer.

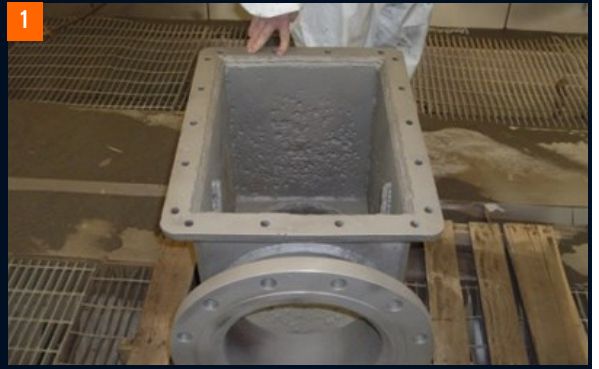
Erosion corrosion was taking its toll on the inner surfaces of this seawater strainer. Years of inadequate protection from inferior coatings was dramatically reducing the span of this important piece of equipment.

1. The extent of the corrosion damage can be seen after the seawater strainer has been grit blasted
2. The pitted areas were rebuilt with Belzona 1311
3. The completed repair after the application of 2 coats of Belzona 1321
