# BELZONA REBUILDS WORN HOUSING

ID: 4784

Worn pin bush housing of the loader

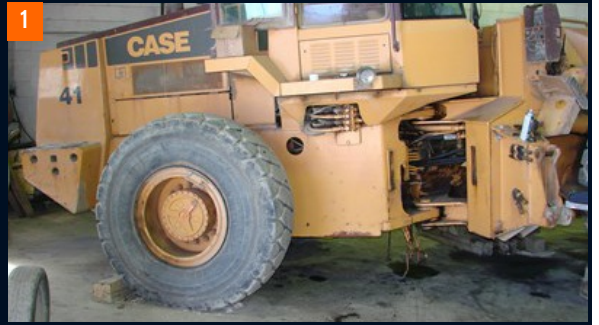
1. This Case front end loader had a worn bushing located in the rear walking beam.
2. The worn bushing was prepared with a die grinder to provide a good bonding surface
3. The new pin was coated with Belzona 9411 before it was reset into Belzona 1111 Super Metal.
