# BELZONA REPAIRS CONCRETE HULL

ID: 4785

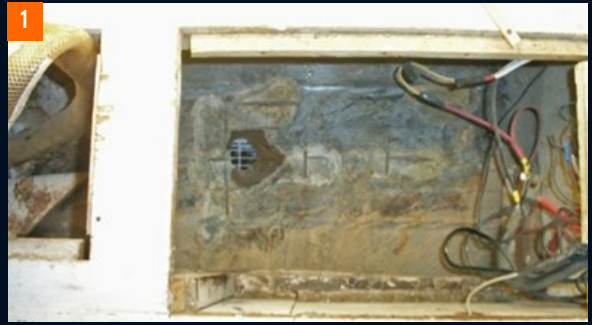
The bottom of the hull had been attacked by leaking battery acid. Also while docked another vessel had collided with the yacht damaging its hull.

1. The concrete hull had been damaged by leaking battery acid
2. After neutralizing and preparing the area with a grinder rebuilding with Belzona 4111 began
3. During the repairs hull was damaged
4. Hull repaired with Belzona 4111 and then sanded down to smooth finish before repainting.
