# BELZONA PREVENTS LEAKS INTO ELECTRICAL ROOM

ID: 4786

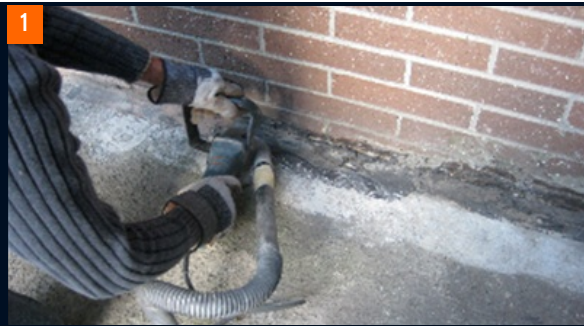
1. Surface preparation underway 2. The area was masked off before the 1st coat of Belzona 3121 was applied 3. A 2nd coat of Belzona 3121 was applied along with reinforcing sheet to ensure that the gap was adequately bridged. A 3rd coat was applied to complete the application.

Application was carried out using a modified version of Belzona System Leaflet RPA-1. The area along the wall and concrete floor was ground with a Vac-grinder to ensure a good surface for bonding before applying the Belzona 3121 system.
