# BELZONA PROTECTS KEEL COOLER

ID: 4787

Keel cooler of a tug boat.

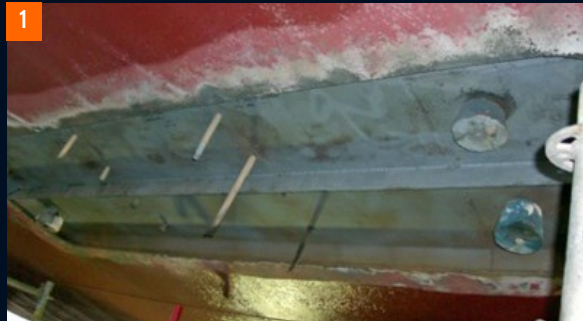
Bi-metallic corrosion was attacking the metal surfaces of the keel cooler. The metal surface had become badly pitted.

1. The inside of the keel cooler was showing signs of severe corrosion
2. The eroded areas were rebuilt with Belzona 1311
3. Finally the entire cooler area was protected with 2 coats of Belzona 1341
