# BELZONA ADDS SAFETY TO SWIMMING POOL STAIRS

ID: 4788

The swimming pool facility was upgrading the access stairs to the diving tower.

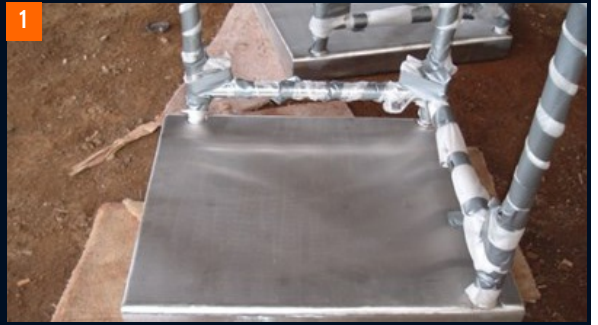
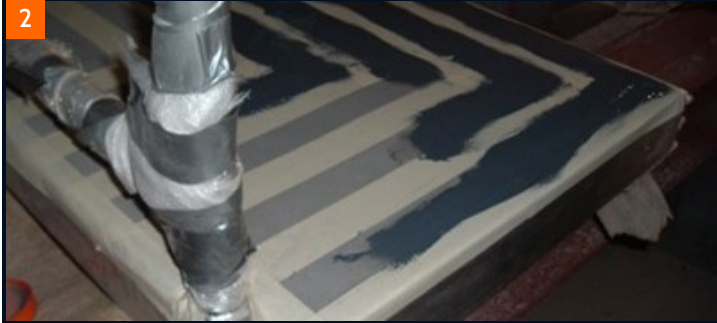
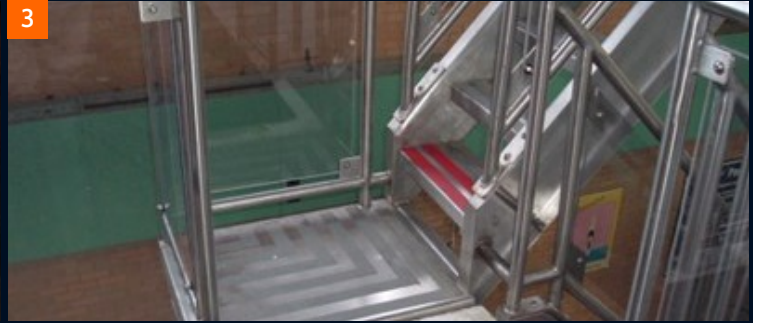
Because of the corrosive environment stainless steel was used for the construction and unfortunately the base was very slippery.

1. The surfaces of the stainless steel landings were grit blasted to ensure good adhesion to the metal surface
2. The area was masked off in a chevron style pattern to ensure adequate safety for the multi directional traffic the landing would be subjected to
3. The completed application installed at the base of the diving tower.

Application was carried out in accordance with a modified version of Belzona Know-How System Leaflet FPA-8.

Belzona non-slip safety systems have been successfully applied in a wide variety of immersed and semi immersed situations. The normal stick-on systems were considered but they did not have the life expectancy of the Belzona system.
