# BELZONA PROTECTS BRINE SEPARATOR

ID: 4794

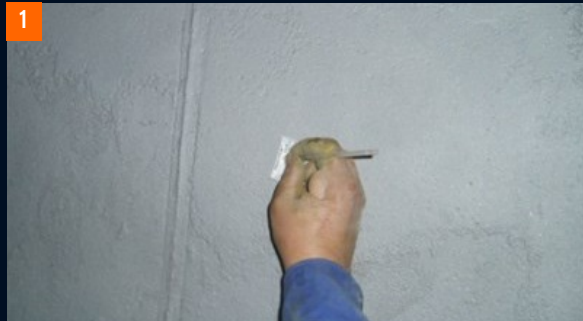
1. Surface after blasting to 3-4mil profile
2. Pitted areas were brush blasted prior to over coating
3. Completed application

The application was carried out in accordance with Belzona Know-How System Leaflet TCC-01. The surface of the vessel was blasted to a 3-4mil profile using aluminum oxide blasting grit. The pitted areas of the vessel were rebuilt with Belzona 1511, a high temperature rebuilding compound specifically formulated for these types of applications. The rebuilt areas were brush blasted prior to over coating. After strip coating all internal weld areas and outer edges, complete vessel and man cover were protected with Belzona 1521.

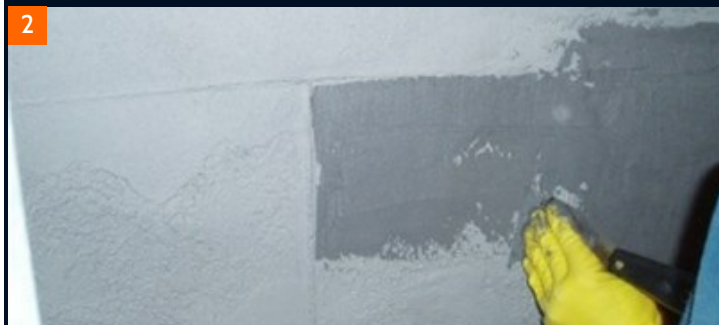
Corrosion pitting and erosion was taking its toll.
