# BELZONA PROTECTS HIGH TEMPERATURE ISOLATION SPOOL

ID: 4799

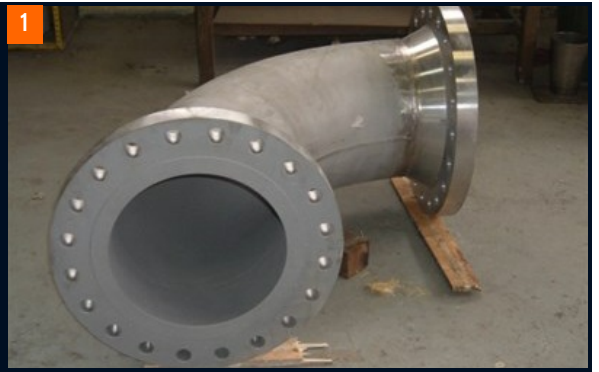
1. Section of piping after surface preparation had been completed
2. A former and machined shims in place to create new flange face
3. Completed application

The application was carried out in accordance with Belzona Know-How System Leaflet VPF-3. After the surface was prepared, a former and machined shims were used to create a new spiral wound flange face. After the flange face forming was complete, the internal surfaces of the pipe elbow had been coated with Belzona 1391.
