# BELZONA STOPS DAMAGE FROM PITTED CHOCKS

ID: 48

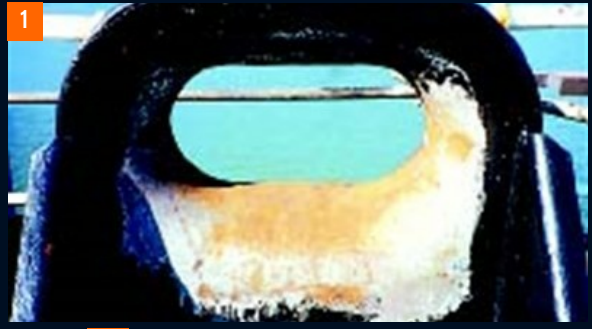
Chocks pitting and the roughness was destroying the hawsers.

Ship's mooring lines (hawsers) are very expensive. The steel casting for the chocks became pitted from the salt. This caused jagged edges which wore out the hawsers prematurely.

1. Close-up of chock with peeling paint.
2. View of chock showing extensive pitting.
3. Surface preparation in progress.
4. Finished application.
