# BELZONA OFFERS IMPROVED SAFETY IN CHEMICAL PLANT

Concrete damage on roads, bunds and plinths

Chemical Plant, UK

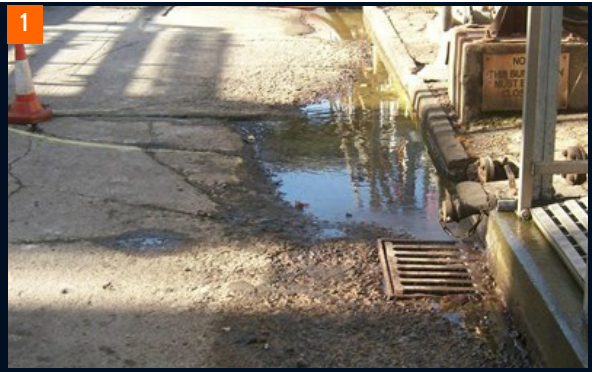
Over many years on this site, concrete surfaces had suffered attack from regular heavy lorry traffic, slab movement and from many chemicals. Concrete surfaces had been cracked or eroded in many areas around the plant, including access roads, pavements, expansion joints, bunds and plinths. Although some of these problems were structural, the main concern for the client was for the trip hazards around the site.

1. Example of typical concrete damage on road
2. Completed repair to road side
3. Completed repair to gulley covers
4. Completed rebuild of forklift ramp

The customer had previously tried conventional cementitious repairs which had not performed well and was looking for a long lasting solution with a proven track record. For deep damage, the Belzona 4131 was bulk filled 50/50 with 6mm pea gravel and resin to reduce costs before topping with Belzona 4131. A total of 1700Kg of Belzona 4131 was used on site throughout the project. Following detailed inspections the client was delighted with the system and is considering its use on other sites with the same problems.
