# BELZONA 4111 (MAGMA-QUARTZ) KEEPS PRODUCTION ON TRACK

ID: 481

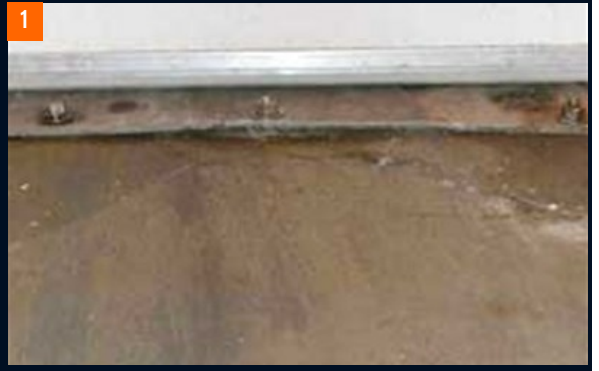
Fork lift traffic damaged stainless steel plate being bent by fork lift trucks pushing pallets into it and lifting it up. Needed a solution to avoid further damage.

1. Close up of the problem
2. Surface prepped
3. Ready for traffic
