# BELZONA SEALS A TRANSFORMER MAIN FLANGE

ID: 4810

Supply Transformer ST6 located at electricity substation within steel manufacturing plant.

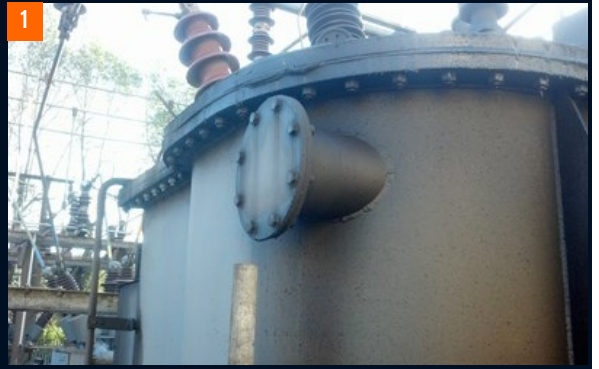
The main flange was discharging high volumes of oil through the failed gasket system, together with loss through the top and bottom bolt heads. Continual tightening of the bolts was no longer proving effective on this aged transformer. The Client sought a comprehensive solution to seal the main flange and bolt heads.

Transformer prior to application Close up substrate preparation Main flange sealed and bolt head encapsulation Repair areas completed following Belzona 5831 coating
