# BELZONA SEALS FIELD JOINTS ON PLATFORM RISER

ID: 4816

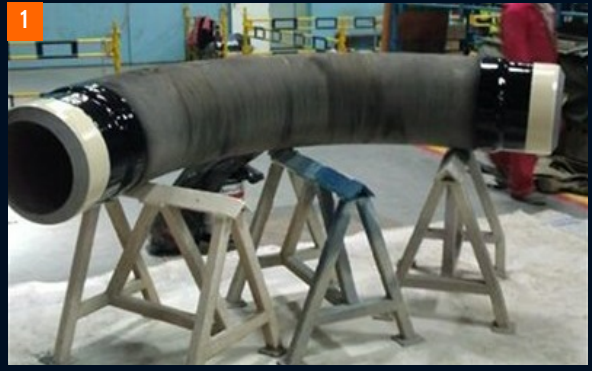
1. Trials carried out in clients workshop
2. First coat of Belzona 2141 being applied
3. Some of the sealed riser joints
4. Close up of a sealed joint

Belzona was selected based on its ability to be applied in-situ. This, together with its ability to bond to the hot surfaces, confirmed by a series of trials carried out in the clients workshops, led to all 42 joints being encapsulated with the Belzona system
