# BELZONA CORROSION PREVENTION ON PLATFORM RISER

Corroded riser on offshore oil production platform

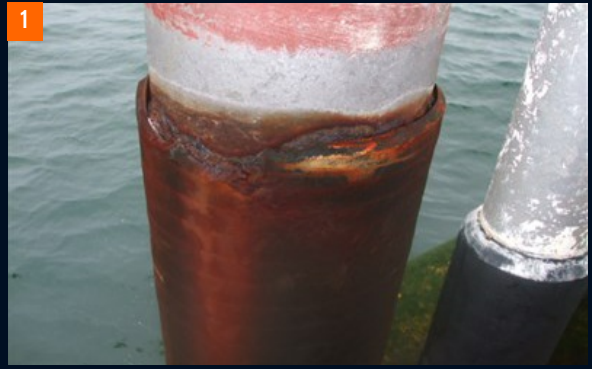
Corrosion was occurring at the top edge of rubber riser sleeve due to water ingress between rubber cladding and riser.

1. Corroded riser
2. Belzona 1321 applied to steel riser
3. Belzona 2211 fillet applied to rubber/riser joint and over-wrapped with more Elastomer incorporating Belzona 9341 to add strength
4. Application completed by applying further Belzona 2211 to encapsulate the joint interface and provide a waterproof seal.
