# BELZONA PROTECTION FOR NUCLEAR POWER STATION CW VALVES

ID: 4819

Butterfly valves controlling main cooling water inlets.

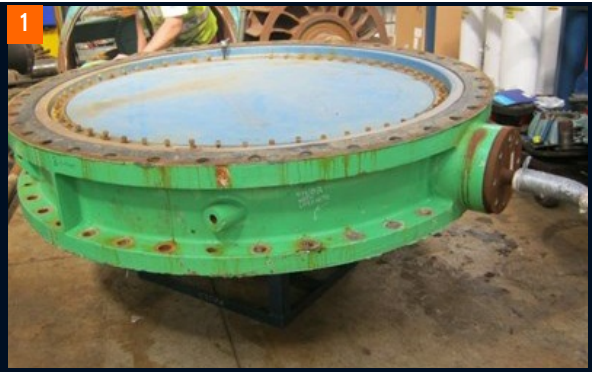
1. MCW Butterfly Valve prior to dismantling
2. Valve body suffering erosion-corrosion
3. Non-pressure side prior to rebuild and coating
4. Non-pressure side rebuild and coated using Belzona 2141

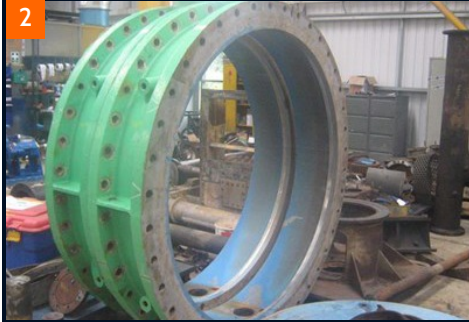
The non-pressure side of the valve had severely eroded due to corrosion and cavitation. The valve body and particularly the disc were affected.
