# BELZONA REPAIRS/PROTECTS LP STEAM DIAPHRAGM

Low Pressure Steam Turbine Diaphragm

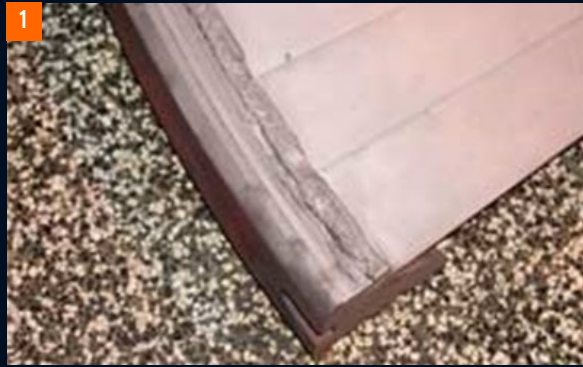
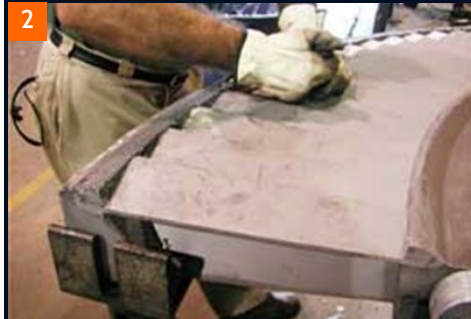
Erosion

1. & 2. Erosion damage is evident
3. Belzona 1111 (Super Metal) in place
4. Completed application

Application was carried out in accordance with a modified version of Belzona Know-How System Leaflets CEP-3 and CEP-5.

Sheet metal shields were produced to go over the diaphragms. Welding was considered, but time and costs associated with that were prohibitive. They were able to avoid the excessive cost of welding and its extended downtime. The Belzona approach kept the equipment out of service only one week, thereby keeping the power plant on schedule during their planned outage.
