# BELZONA REPAIRS AND PROTECTS LEAKING BALCONY

ID: 4823

90m long concrete balcony giving access to flats over shop units.

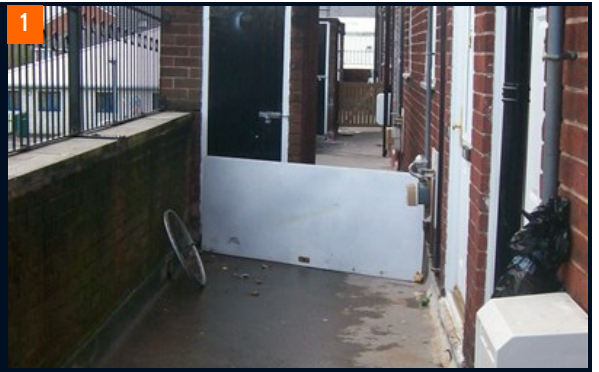
Over the years the cantilevered balcony had dropped allowing a gap to form between wall and the balcony itself. There was then water ingress through the gap into the shops below.

1. Balcony before work commenced
2. During the application
3. Completed application
4. Further view of the completed application

The application was carried out in accordance with Belzona Know-How System Leaflets RPA-2 & RPA-8. Belzona 4111 was used to rebuild damaged masonry and then the entire area was sealed with a fully reinforced Belzona 3111 system before applying a further coat of Belzona 3131 blended with Belzona 9231 aggregate to create a hard wearing non-slip surface.
