# SUCCESSFUL RESTORATION OF ROOF IN CENTRAL LONDON WITH BELZONA

ID: 4824

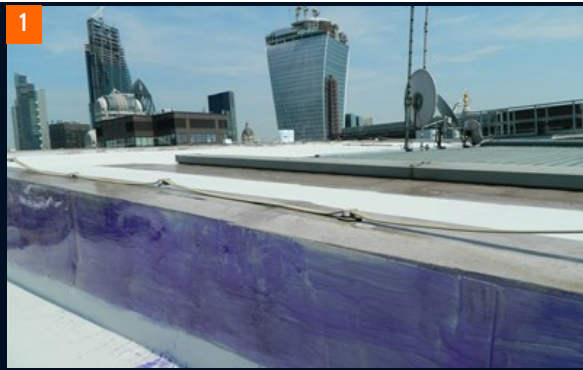
Surface being conditioned to ensure good adhesion  
First coat of Belzona 3111 applied  
Completed application  
Completed application

The application was carried out in accordance with Belzona Know-How System Leaflet RPA-1. The upper level roof was cleaned and prepared before application of a fully reinforced Belzona 3111 system.
