# BELZONA SAVES ENGINE BLOCK

ID: 4825

The customer provides high end restoration services for vintage cars. Currently working on an Aston Martin DB6 engine block

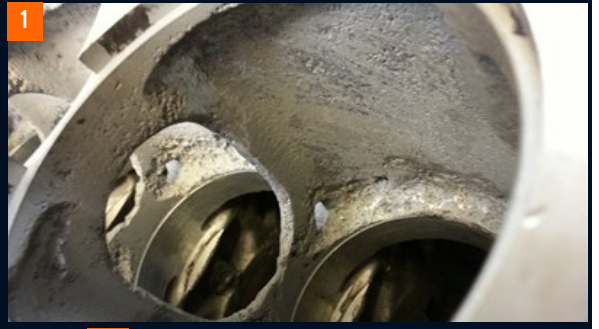
The engine block had a hairline crack and was badly pitted around the cylinder liners. Due to the location of the crack, it was difficult to reach to weld effectively and the pitting needed to be eradicated.

The damaged engine block prior to cleaning The block being repaired with Belzona 1111 Second coat of Belzona 1392 being applied The finished block
