# BELZONA IN WATERWORKS' PUMP SAVES OVER \$7,200 ANNUALLY

ID: 483

17 million gallons/day water pump

Des Moines Water Works, Des Moines, Iowa USA

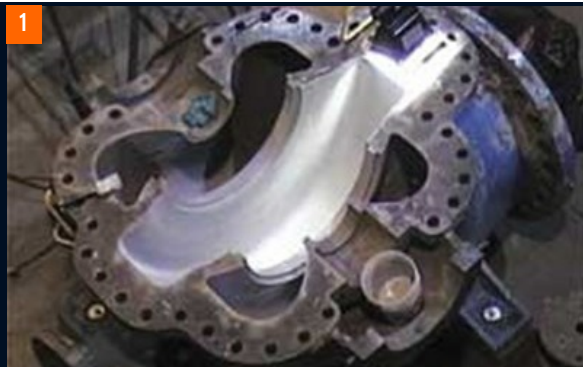
1. Surface prepared for application
2. The impeller was also repaired/protected with Belzona
3. In progress
4. Complete, and ready for re-assembly

Repair of erosion damage with Belzona® 1221 (Super E-Metal). Then a two-coat application of Belzona® 1341 (Supermetalgilde) was applied. Belzona® 1341 is approved by NSF for potable water contact. Performance tests showed an average increase of wire to water efficiency of 7.2%, which will save over \$7,200 annually.
