# BELZONA FIXES TRIP HAZARD

ID: 4830

Stone floor at threshold to college main canteen servery.

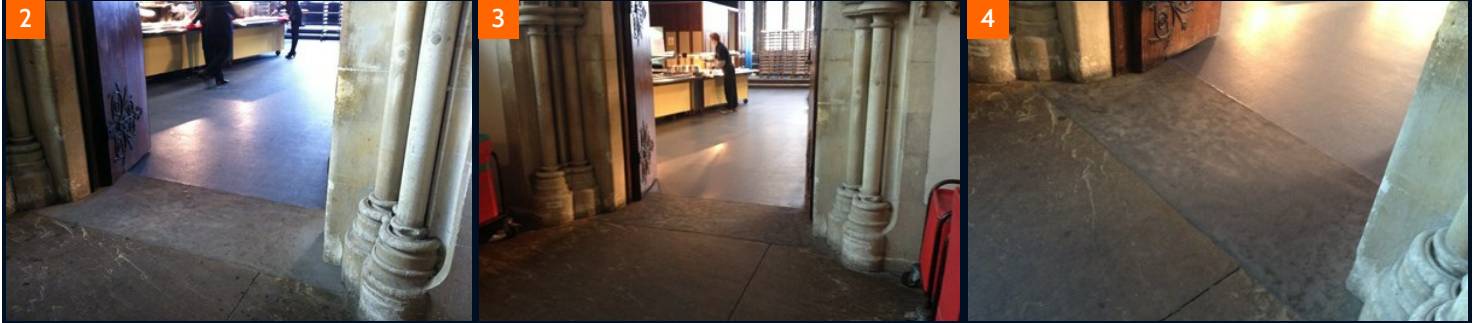
The stone had worn down over the years creating a lip of about 20mm between the stone floor and the adjoining vinyl floor, creating a trip hazard. They required a repair sympathetic to the stone and which would cause minimal disruption to the canteen operations.

1. Before application 2. Completed application 3&4. Repair still in good condition following revisit 2 years on

Application was carried out in accordance with Belzona Know-How System Leaflet FPA-1.

The client had previously used other cementitious repair systems in the past which had failed prematurely. They turned to Belzona after seeing how Belzona 4131 can be used in harsh environments and returned to service quickly. Following a recent revisit two years since the application, the repair remains in excellent condition.
