# BELZONA RINGS A TUNE

ID: 484

161-foot bell tower

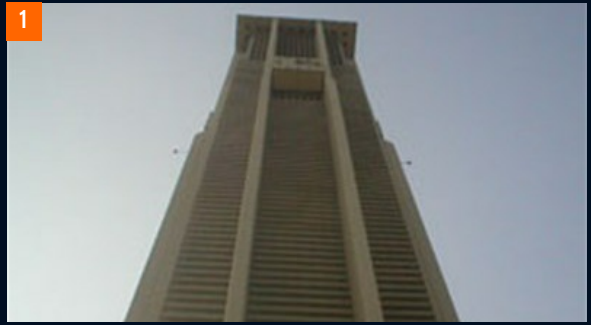
1. The bell tower
2. Leaks were allowing water to ingress the bells bellow
3. Problems clearly evident
4. Completed roof repair

The roof area is approximately 30 square feet with a hatch opening. Customer had been advised that the roof should be removed to be repaired. Belzona® 3111 was used to repair the roof in place, saving significant amounts of money.
