# BELZONA KEEPS THE SHOT BLASTING GOING

A metal part in the shot blaster caught the belt during operation and severely ripped the belt.

Rubber belt tumbler inside a shot blast machine.

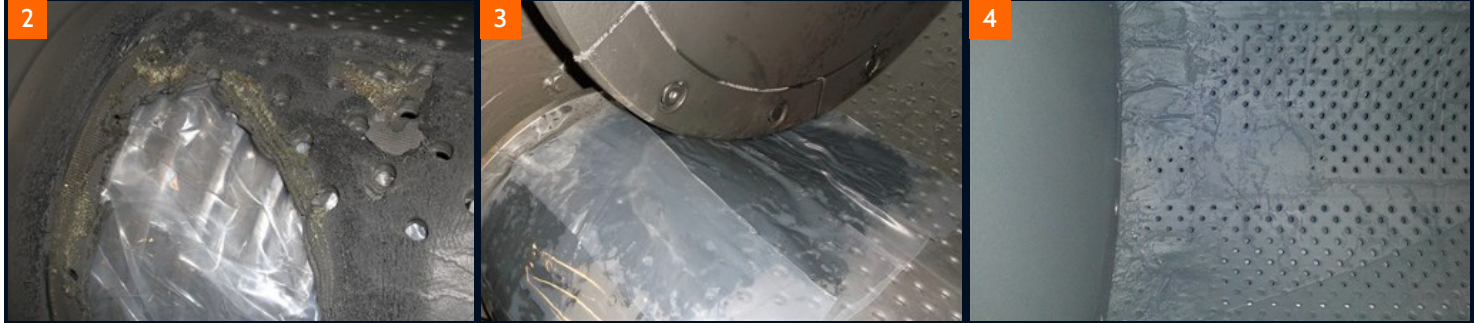
1. Damaged belt 2. Roughened up area ready for application 3. Application completed and covered with plastic 4. 2 weeks later after use

Application was carried out in accordance with a modified Belzona Know How System Leaflet SHM-1. Guard plates were removed allowing for partial access to the complete area to be repaired. All loose material was cut away and the area prepared with a roughening brush. Plastic was slipped underneath the belt to prevent any attachment to the metal drive rollers. Belzona 2911 was applied. Then Belzona 2211 was applied in two layers with Belzona 9341 over the seam areas. The entire job was completed in three sections due to accessibility and covered with plastic so the belt could be moved to complete the application. A heat lamp was mounted to maintain optimum curing temperature.
