# REDUCED DOWNTIME, COSTS SAVED WITH BELZONA

ID: 485

Skimmer rail on a large clarifier - 630' circumference

Alumina plant - Texas USA

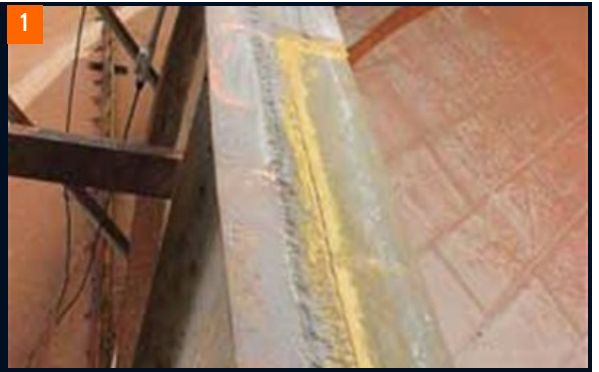
Erosion-corrosion and wear from motion of skimmer and seaside location.

1. The erosion-corrosion problem is evident
2. Close-up view of the damage
3. A 4" band around the circumference was repaired
4. Completed repair
