# BELZONA PROTECTS INTERNAL OF BACK-UP SEPARATOR

ID: 486

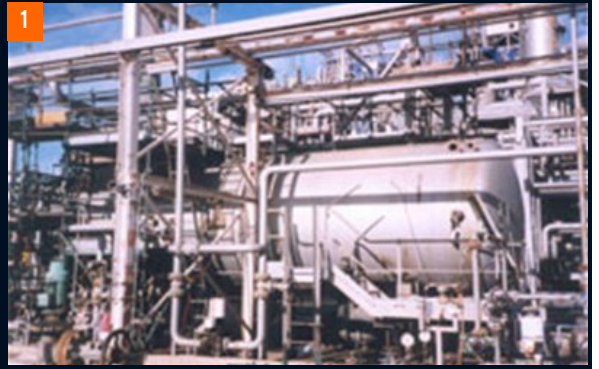
1. General view of the vessel
2. Failed previous coating
3. Application underway
4. One of the three baffles coated and surrounding area partially coated

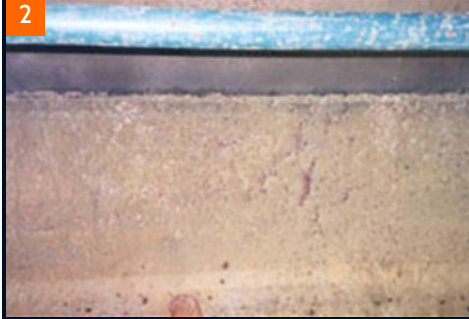
Internal erosion-corrosion caused by presence of sour water and operating temperature up to 100°C.

Previous coating, a vinyl ester epoxy, had failed due to operating temperature. Belzona® 1391 selected based on previous experience in similar environments.

Application was carried out in accordance with Belzona Know-How System Leaflet TCC-5. After thorough cleaning and removal of previous coating, the vessel was grit blasted and coated with the Belzona® 1391.
