# BELZONA PROTECTS CONVEYOR BELT FASTENERS

ID: 4867

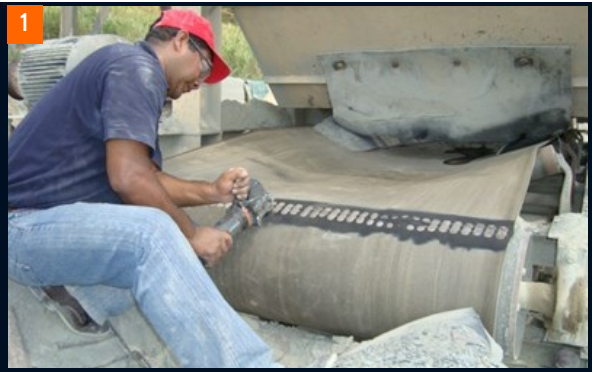
1. Surface preparation
2. Surface conditioning
3. Application of Belzona Elastomer
4. Fasteners protected.

Application was carried out in accordance with Belzona Know-How System Leaflet SHM-4. Surface was prepared using an MBX-Bristle Blaster before applying the Belzona Elastomer system.

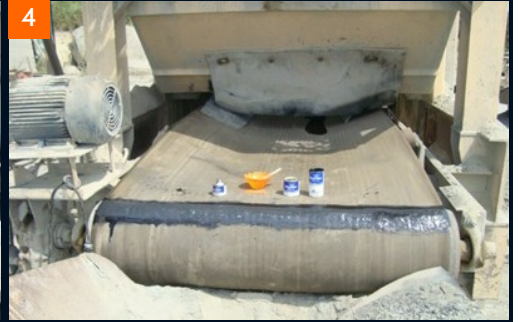
The belt fasteners were presenting mechanical problems due to premature failure. Client wanted fasteners sealed and protected with Belzona Elastomers

The downtime of the conveyor belt due to failure of the fasteners has a high cost due to lost production. With the protection that Belzona offers, the downtime is reduced to a minimum and the life of the fasteners extended.
