# BELZONA BRINGS EXCAVATOR BACK TO SERVICE IN 1 DAY

ID: 4869

Excavator shovel at salt mine

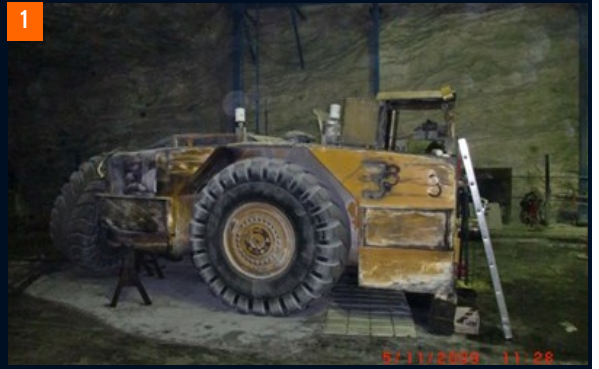
The severe conditions of corrosion and abrasion in the mine caused loss of metal in the articulated coupling, which resulted in reduced service life of the component.

1. Excavator shovel before the application
2. Injection of Belzona 1821
3. Final application
4. Bearing back to service
