# VULCANIZING COMPANY SAVES TIME AND MONEY

ID: 4870

Off-road tractor's tire

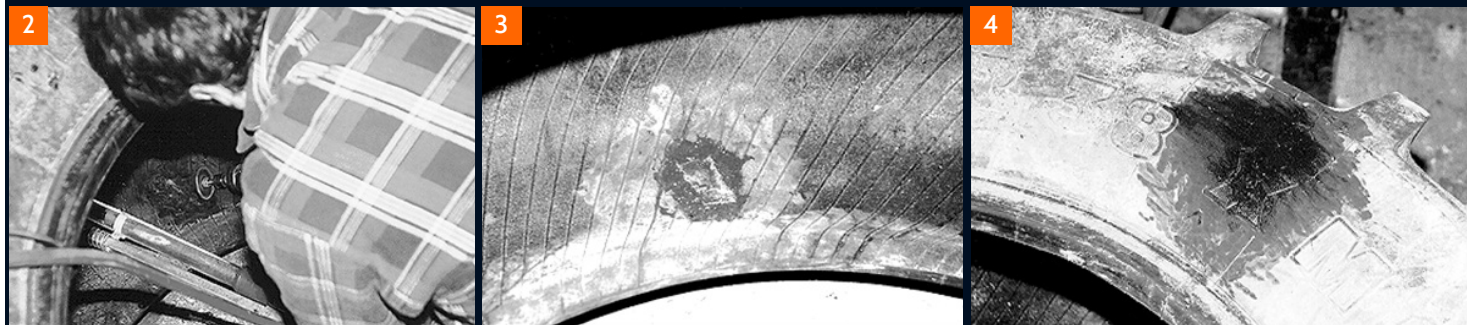
## PHOTOS

The tire had a cut which penetrated right through the wall, requiring repairs to be performed not only on the outside but on the inside of the tire as well.

1. Inside portion of the tire before the repair
2. Surface preparation in progress
3. Inside repair near completion
4. Finished repair to the outside

The affected areas (both inside and outside of the tire) were abraded then fully cleaned and degreased. Then, the substrate was conditioned using Belzona 2911 (Elastomer QD Conditioner). Belzona 2311 (SR Elastomer) was then mixed and applied incorporating Belzona 9341 (Reinforcing Tape) to the area around the damage.

The tire was returned to service and is performing as good as new. This Belzona repair was quick and easy to complete, saving time and money to the end client.
