# BELZONA EROSION CORROSION PROTECTION APPLIED BY SPRAY

ID: 4871

Oxygenation vessel on offshore oil and gas platform

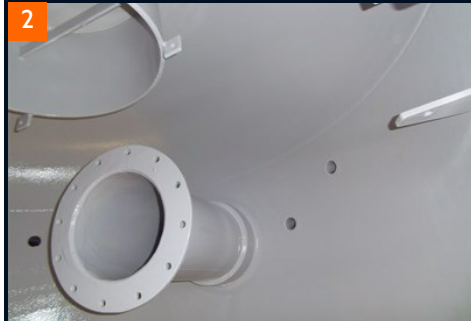
1. Application of the first coat of Belzona 1331 (white) 2. Application of the second coat of Belzona 1331 (grey) 3. Internal furniture and brackets were coated separately 4. Finished coating with detailed areas completed by hand

Application was carried out in accordance with Belzona System Leaflet TCC-5. Following thorough surface preparation by grit blasting, Belzona 1111 was applied to fair off welds and in fill areas which had suffered from pitting. Belzona 1331 was then applied as a two-coat system by heated airless spray to provide overall erosion corrosion protection.
