# MARINE EXHAUST SYSTEM INTERNALLY PROTECTED WITH BELZONA

ID: 4876

## PROBLEM

Marine exhaust system for luxury yacht. Components to be protected were pipe sections 125mm in diameter with lengths varying between 1.9 meters and 6 meters

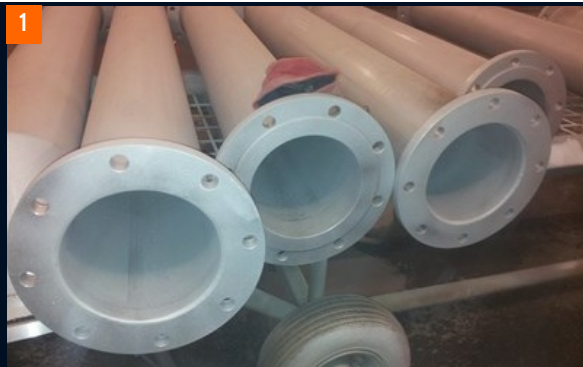
1. Exhaust sections following internal grit blasting
2. Internal pipe lining in progress using Belzona 1381
3. Completed application
4. Close up of finished pipe end showing Belzona 1391T

Application was carried out in accordance with Belzona System Leaflet VPF-2. Belzona 1381 was applied using a single airless spray pump and internal pipe lining equipment. The ends and flange faces were hand finished using Belzona 1391T.
