# BELZONA PROTECTS VERTICAL FLARE KNOCK OUT VESSEL

ID: 488

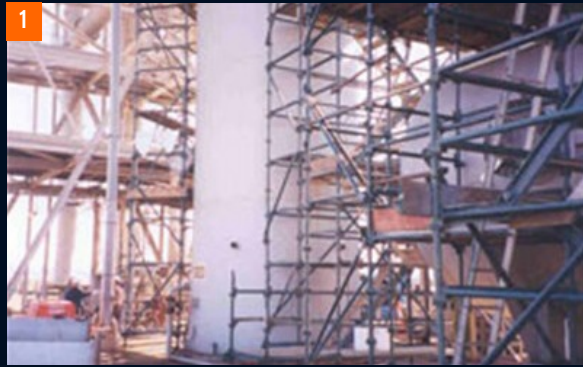
Vertical Flare knock-out vessel. This is second stage of the flare stack line and is half filled with water to form a seal for dissolved Hydrocarbons, H<sub>2</sub>S but mainly sour water.

1. General view of the vessel
2. The degree of existing corrosion found in the vessel
3. Application of Belzona 5891 underway

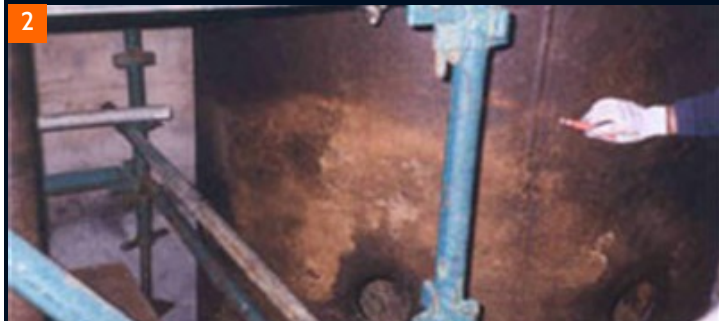
Internal corrosion caused by variety of hydrocarbons and chemicals passing through the vessel.

Application was carried out in accordance with Belzona Know-How System Leaflet TCC-5. After thorough cleaning, the vessel was grit blasted and coated with the Belzona® 5891.
