# BELZONA REPAIRS A DRAGSHAFT

ID: 4883

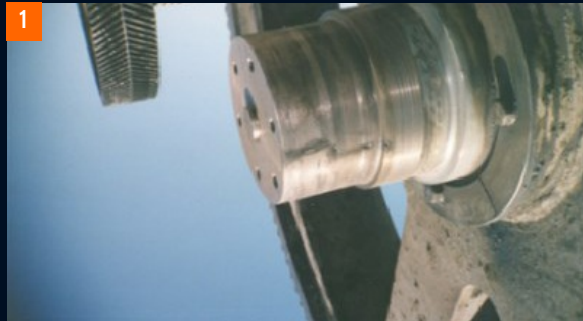
Worn shaft due to bearing failure

1. Initial damage
2. Surface Preparation
3. Molding Belzona 1111
4. Complete application
