# LEAKY ROOF REPAIRED WITH BELZONA DODGING A THUNDERSTORM

ID: 4885

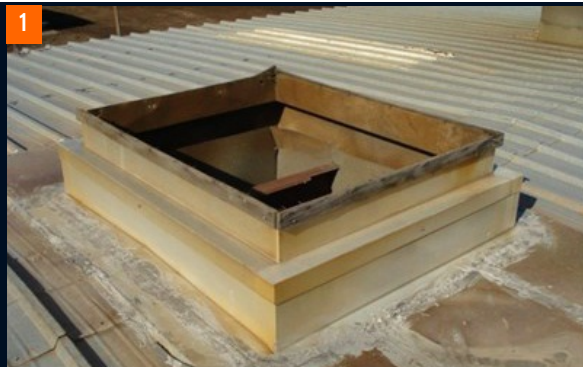
The warehouse roof leaked for over 20 years with 5 different contractors trying to fix it.

1. Problem area
2. Application in progress
3. Complete application
