# BELZONA REPAIRS SWING SHAFT BUSHING

ID: 4886

Damaged swing shaft bushing on a dragline

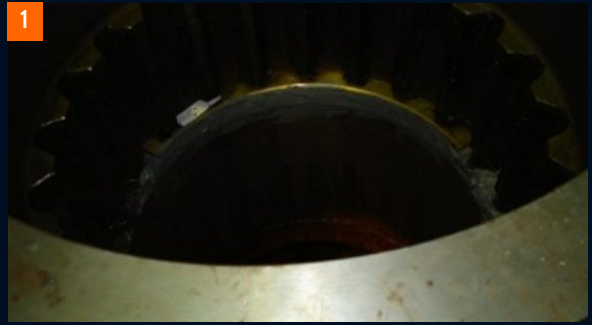
Swing shaft bushing are segmented brass and fit loosely. Belzona was used to shim the OEM bushings for a tighter fit.

1. Damaged bushing
2. Application in progress
3. Complete application

Bushings were replaced often due to the loose fit. Belzona 1111 repair augmented the OEM fit thus improving run life.
