# BELZONA SAFETY GRIP SYSTEM FOR ROOF ACCESS STAIRS

ID: 4887

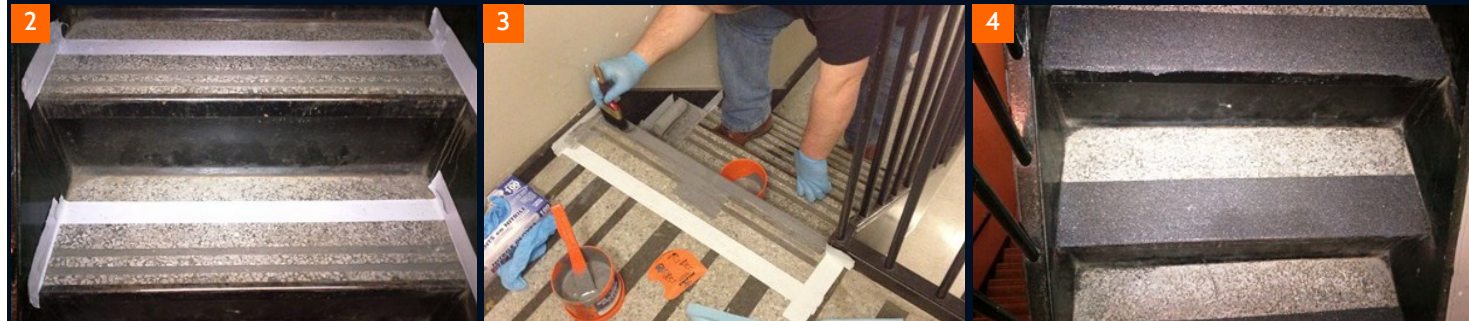
Extensive water and salt exposure had made it virtually impossible to maintain the Health and Safety requirements for any extended period of time.

Access to the roof via the smooth stairs.

1. Stairs prior to application
2. Preparation complete
3. Application in progress
4. Complete application

Application was carried out in accordance with Belzona Know-How System Leaflet FPA-8. Removed the existing adhesive tape and prepared the area ready for application. Belzona 4411 with Belzona 9211 was applied to eighteen steps and nosings.
