# BELZONA REPAIRS CRUSHER'S BASE

ID: 4889

Interior of the crusher's base.

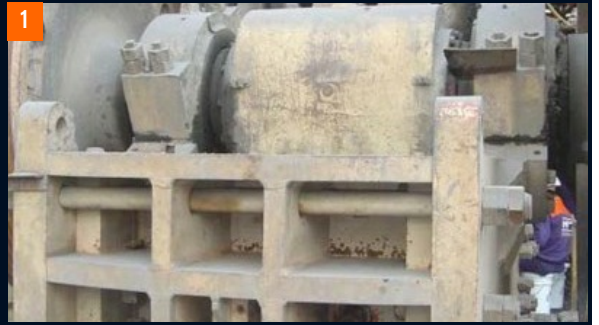
1. General view of the crusher
2. Crusher's base with exposed metal structure
3. Application of Belzona 4111
4. Crusher's base repaired with Belzona technology

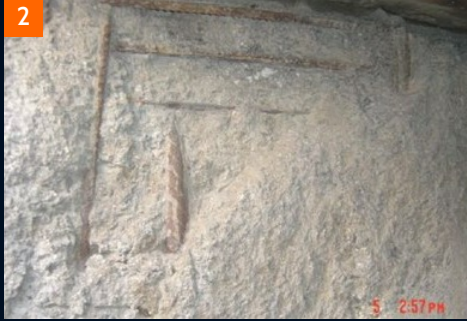
Over time, the vibration of the 100 ton machine caused the breakage of two fastening screws of the concrete base. The equipment became tilted and some parts of the concrete were already showing the metal structure, causing their oxidation. It was necessary to recover the surface with a concrete repair product with excellent mechanical resistance.

The application was carried out based on Belzona Know-How System Leaflet FPA-1. Surface was prepared with abrasive grit blast and wire brush. After that, the conditioner Belzona 4911 was applied on the concrete and Belzona 4111 was applied to fill out the damaged areas and to rebuild the corner of the base.
