# LOWER HALF OF KNOCK OUT VESSEL PROTECTED WITH BELZONA

ID: 489

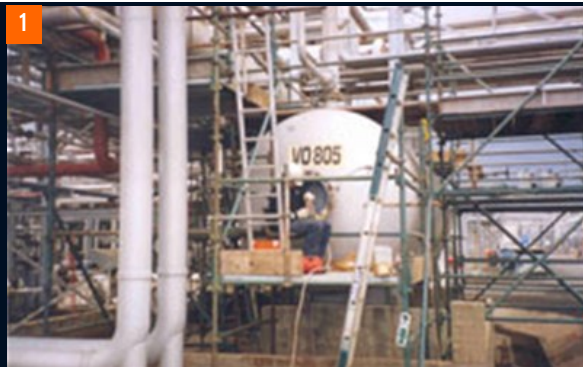
Internal erosion corrosion in lower section caused by sour water. Vessel regularly steamed out.

1. Typical limited access to vessel through manway
2. Application of Belzona 1391 underway
3. Completed application

Application was carried out in accordance with Belzona Know-How System Leaflet TCC-5. Belzona® 1311 was used to repair pitting (particularly in 4-8 o'clock positions) and to smooth out weld repairs after which the lower half of the vessel was coated with Belzona® 1391.
