# BELZONA REPAIRS A SCREEN'S BASE

ID: 4890

Screen's Base

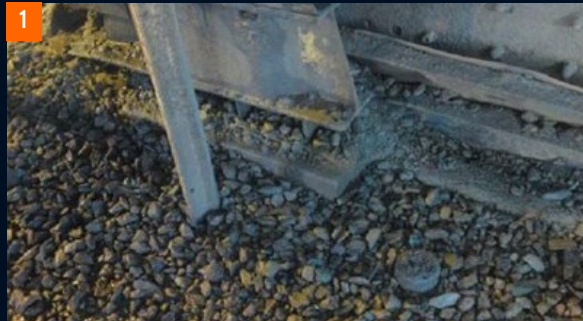
Excessive vibration generated wear and slack on the screen's concrete base, resulting in damaged anchor bolts.

1. Screen's base
2. Wood mold for the base
3. Base with Belzona 4124
4. Application of Belzona 4111/4151.

The application was carried out based on Belzona Know-How System Leaflets TCC-9 and FPA-10. The concrete surface was prepared by mechanical scarification. Metallic surface was prepared using mechanical and manual tools according to application standards. After cleaning, the conditioner Belzona 4911 was applied on the concrete. Belzona 4124 was used to fill the base and Belzona 4111/4151 was injected to set the anchor bolts in place.
