# BELZONA RECOVERS BALL MILL'S BASE

Ball mill engine and gearbox base

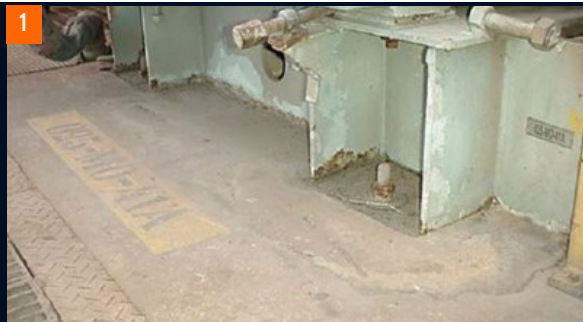
In an inspection conducted by the producer, it was found that there was a very high vibration caused by excessive gap at the base of the ball mill engine and gearbox. It was necessary to provide an effective solution for the situation not to worsen over time.

1. Mill's base before product application
2. Application of Belzona 4911 conditioner
3. Product application by injection
4. Base after application of Belzona 4111/4151

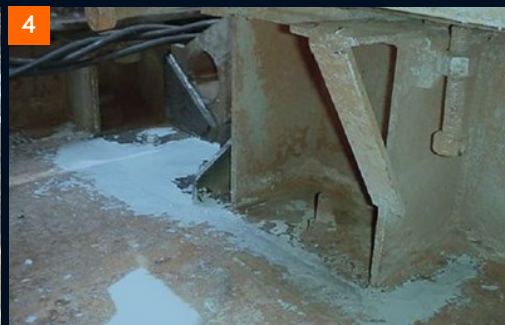
Following data was found through vibration analysis: Before application – average vibration of 10.57 mm/s<sup>2</sup>. After application – average vibration of 3.38 mm/s<sup>2</sup>. Based on that, it was concluded that Belzona's technology reduced the vibration effects on the equipment by 1/3.
