# BELZONA APPLIES ANTICORROSIVE COATING ON A THICKENER

ID: 4896

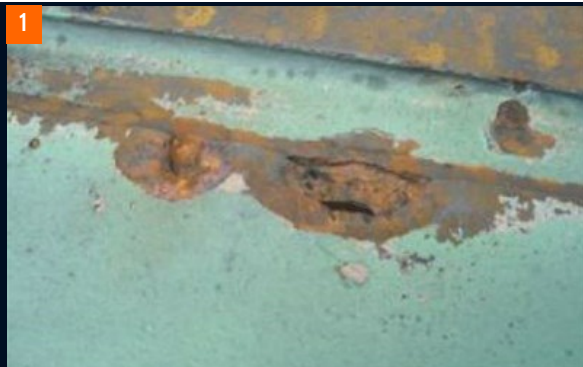
The wall area and the bottom of the thickener presented areas with localized corrosion, which needed thickness and internal lining repair. In addition protection of the steel plate against corrosion, caused by copper pulp at room temperature, was required.

1. Hole on the bottom of the thickener
2. Hole on the wall of the thickener
3. Supporting beam on the bottom of the thickener coated with Belzona 1321
4. Wall coated with Belzona 5831

The coating was applied on half of the internal area of the wall and on half of the support beams of the bottom of the thickener based on Belzona Know-How System Leaflets TCC-1 and TCC-5. First, the thickener was washed to remove the copper ore residues. Following the surface preparation, with dry abrasive blast to achieve near white metal finish, the holes, pits and existing welds were repaired with Belzona 1311. After that, Belzona 1321 was applied on the bottom of the thickener, and Belzona 5831 was applied on the wall.
