# BELZONA SAVES CORRODED SPRINKLER TANK BY PLATE BONDING

ID: 4899

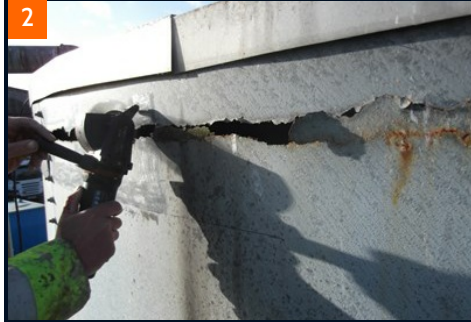
Over several years the tank had become badly corroded at the water line around approx. 50% of the circumference, causing it to split open in some areas with water constantly flowing out.

1. Large sprinkler tank with corrosion at water line
2. Surface being prepared with MBX Bristle Blaster
3. 36 off 400mm long x 300mm high steel plates being installed using Belzona 1161
4. Installation of steel plates completed and coated with Belzona 5831
