# BELZONA RESTORES JAPANESE ALUMINUM END COVERS

Aluminum end covers from formers of Kobayashi paper machine. Six formers with two end covers per machine.

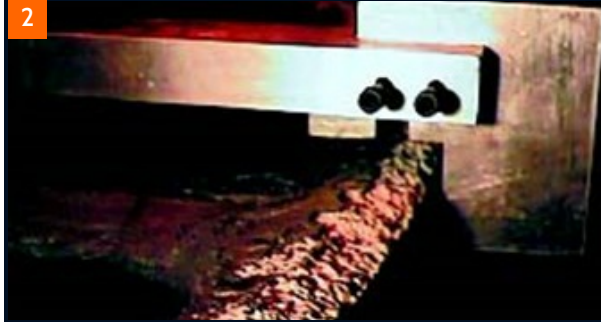
Severe erosion caused by a combination of corrosive environment and abrasion of a fanbelt.

1. The corroded end cover.
2. Work in progress.
3. The end cover repaired and ready for service.
