# BELZONA PROTECTS INTERNAL BASE OF SEPARATOR

ID: 490

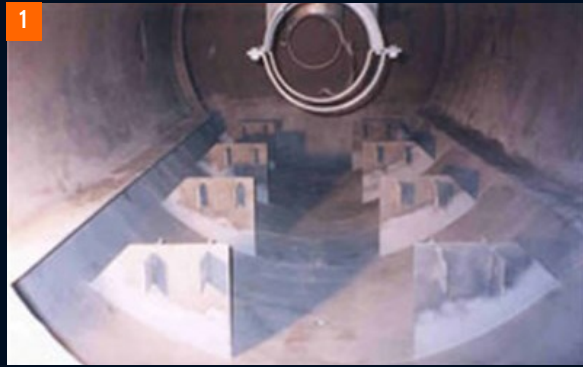
1. Base of vessel grit blasted
2. Stripe coating of welds carried out
3. Completed application

Application was carried out in accordance with Belzona Know-How System Leaflet TCC-5. After thorough cleaning, the vessel was grit blasted and coated with the Belzona® 1591 taking care to initially stripe coat around the attachment bracket welds.
