# BELZONA APPLIES POSITIVE GRIP SYSTEM ON DRIVE PULLEY

ID: 4915

Drive pulley of main conveyor belt.

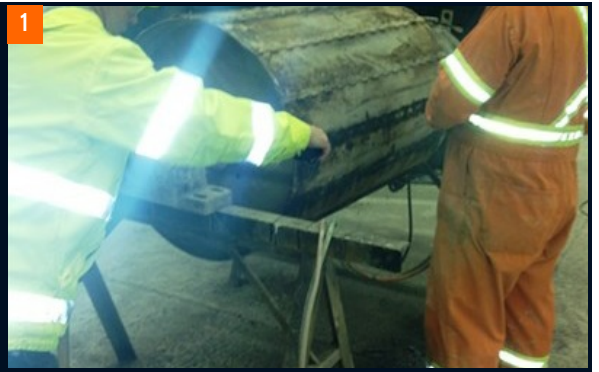
Existing steel lagging to create traction failed. This creates exposed edges which could possibly tear the belt.

1. Drive pulley prior to application
2. Preparation completed
3. Application in progress
4. Complete application

Application was carried out in accordance with Belzona Know-How System Leaflet SHM-12. The surface was prepared by initially grinding the steel to create a clean surface and then abraded with the MBX Bristle Blaster to create the correct surface profile. After surface preparation, duct tape was then applied to chevron pattern. Belzona 1821 was applied to the steel and Belzona 9211 was applied over the Belzona 1821 in accordance with the Belzona Instructions For Use.
