# BELZONA ADDS LIFE TO ASH LINES

ID: 492

Pipes carrying coal ash

Power station in Macedonia

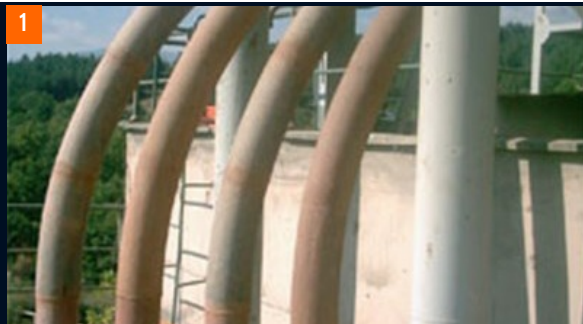
The pipes had worn thin through constant abrasion from the ash. Although not leaking, plant needed to extend life of the pipes before they failed.

1. The pipes before preparation
2. Belzona 1811 being applied to pipe and patch
3. The completed application
