# CORROSION PROTECTION FOR ROLLERCOASTER

ID: 4920

Uncoated and unprotected carbon steel structural anchor bolts exposed to outdoor elements causing Corrosion at a large theme Park attraction.

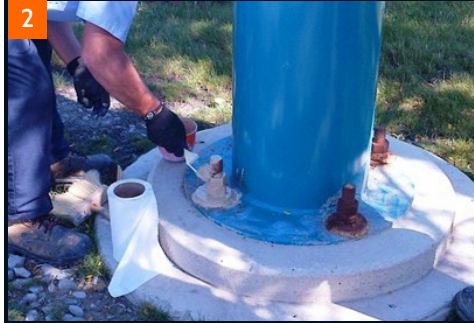
1. Anchor bolts prior to application
2. Application underway
3. View of an anchor bolt finished application
4. Completed application

The application was carried out in accordance with Belzona Know-How System Leaflet VPF-2. The surface was prepared by removing any contamination by rotary wire wheel and then cleaned with Belzona 9111. Two coats of the Belzona 5831 were applied with a brush to the anchor bolts in accordance with the Belzona Instructions For Use.
