# EFFICIENCY ENHANCEMENT KEEPS SLUDGE MOVING

ID: 4921

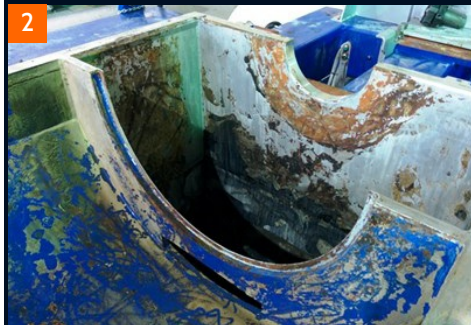
1. External view of dewatering centrifuge
2. Dewatering centrifuge prior to application
3. Surface preparation underway
4. Completed application

Application was carried out in accordance with a modified version of Belzona Know-How System Leaflet CEP-3. Surface preparation was done by grinding off the existing paint system and corrosion. Then carefully created a cross hatch profile to ensure a good anchor for the coating. Two coats of the Belzona 1341 were applied by brush in accordance with the Belzona Instructions For Use.

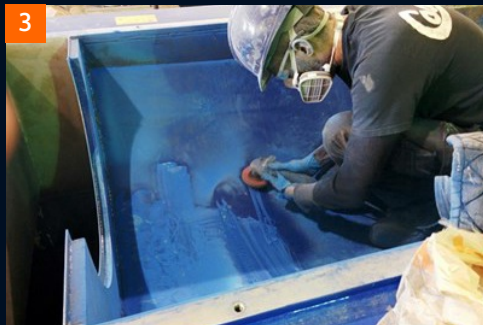
The Dewatering Centrifuges were suffering from struvite and required regular cleaning and maintenance to keep them in operational condition
