# DAMAGED FLOORING IN JAIL KITCHEN

ID: 4923

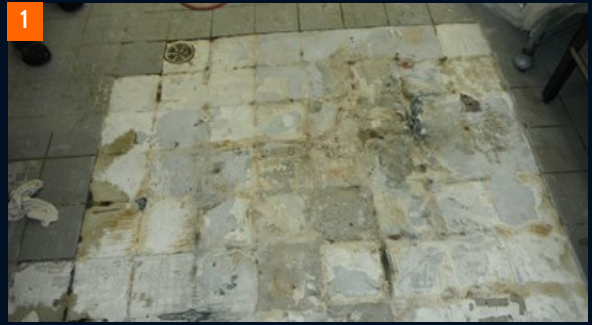
1. Complete preparation
2. Kitchen floor prior to application
3. Complete application

Application was carried out in accordance with Belzona Know-How System Leaflet FPA-1. To prepare the area, the broken tiles were removed down to the concrete and cleared of any loose material or contamination and abraded to expose the aggregate. Concrete was treated with a layer of Belzona 4191 prior to the Belzona 4131 application. Belzona 4131 was applied to the area initially spreading to a general level using normal screeding technique and then smoothing off using a steel float in accordance with Belzona Instructions For Use.

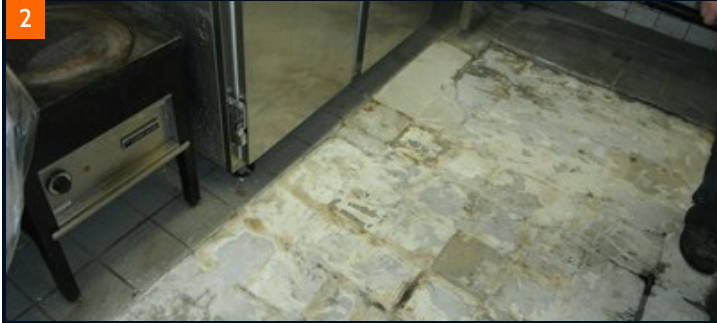
The kitchen floor tiles were undermined by water, penetrating the grout and loosening the tile adhesive causing them to lift and break. This created a Health and Safety issue.
